**PROJECT:** Midnite Mine Remediation **REPORT NO:** 2019-010

OWNER: Newmont/Dawn Mining OPERATOR: Newmont/Dawn Mining

This weekly report provides a summary of Midnite Mine Site (Site) remediation action (RA) construction activities, quality assurance (CQA), quality control (CQC) and engineering activities for the period May 31 – June 6, 2019. The Site activities discussed in this weekly report include, but are not limited to: Site Health, Safety, and Security; Community Liaison, Project Meetings, Regulatory Oversight, Site Visitors; Site Mobilization; RA Activities; Project Documentation; and Site Inspections.

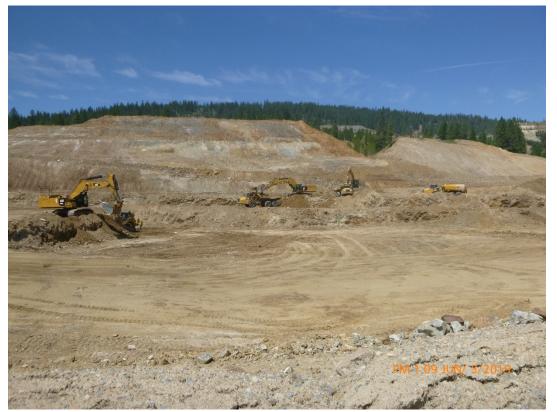
Figure 1 - 390 Excavator loading SWRP material from South pond excavation at left side of photo. Two excavators in background loading material from SP-5

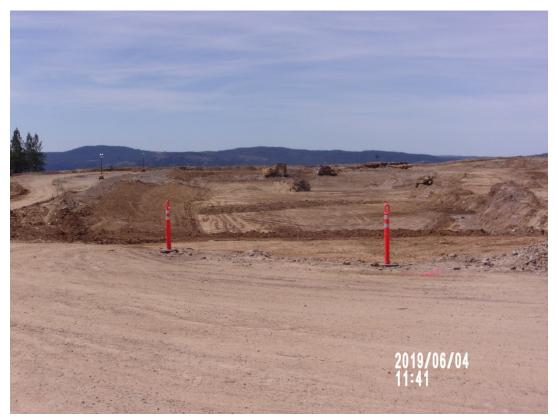
Figure 2 – 390 Excavator loading SWRP material from South Pond excavation at left side of photo.

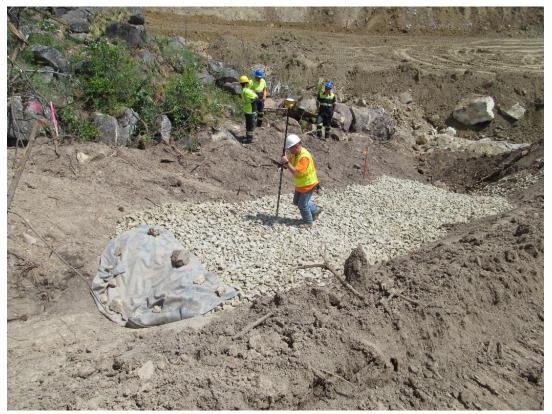
Figure 3 -CQC surveying top of drain gravel of a section of the second lateral of the west IC

- Subgrade compaction.
- GCL placement.
- Placement of a minimum 12 inches of drain gravel.
- Began excavation of the main collector extension to the north
- Wood Chipping Activities
  - o Mobilized equipment on 6/3/2019.
  - Began chipping trees on 6/5/2019.

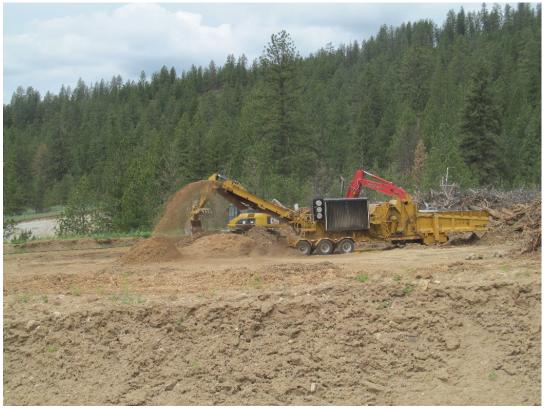
Figure 4 – Wm. Winkler grinding timber in the TISS.

- Wm. Winkler, the tree chipping contractor, mobilized to Site on June 3. The tree grinding operation
  is setup at the tree storage stockpile at the north end of the Temporary Impacted Soil Stockpile
  (TISS).
- Started excavating Hillside Waste Rock Pile (HSWRP) material from the southwest corner of Pit 4
  where the cover will tie-in to native ground.
- Used BMP materials from onsite stormwater controls were disposed of in Pit 4 as Unclassified Waste in accordance with specification section 02205 on June 6.
- Prepared subgrade of 47 additional feet of Infiltration Collector (IC) on the west side of Pit 4 and installed Geosynthetic Clay Liner (GCL) and Drain Gravel.
- Pit 4 tension crack was measured on June 3. The horizontal distance between movement pins remains at 53.75 inches, indicating no measurable movement.
